PROPERTY INSPECTION REPORT

INSPECTION ADDRESS
1234 ANY STREET
OAKLAND, CA 94661

FEBRUARY 8, 2005

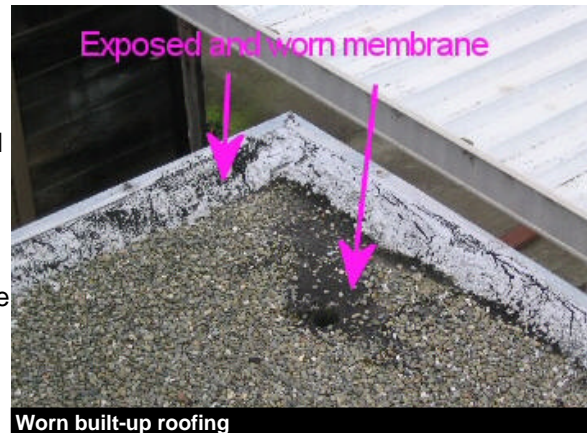
The gravel is not properly embedded in several places, leaving the membrane exposed. We recommend coatings be applied as needed to protect the roof surface from the sun, and the gravel be properly distributed.

The asphalt surfaces are exposed in several places at the roof perimeter. We recommend the exposed perimeter areas be coated to provide protection from sun damage.

The roof membrane is damaged in several places.

We recommend examination and repair by a qualified roofing contractor.

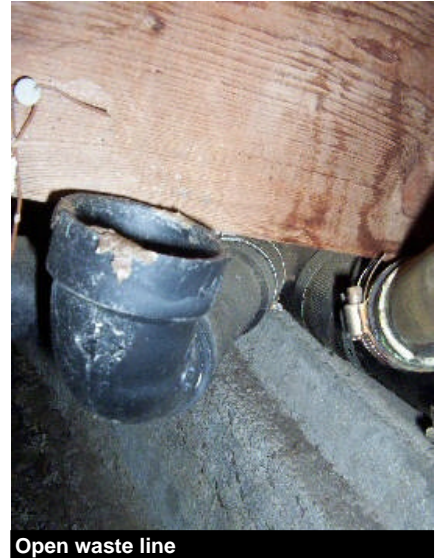
There is an open waste pipe in the rear subarea. We recommend the open pipe be capped off to prevent the escape of sewer gas (potentially combustible methane) from the sewer system.

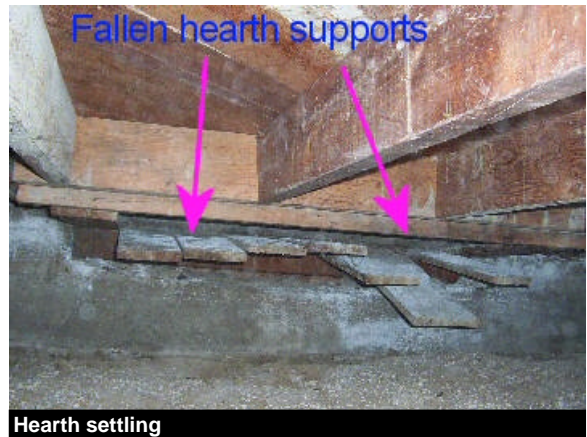
The hearth extension is supported by wooden framing. The framing below the hearth has come loose in the subarea. We recommend the loose support framing be removed and the hearth be properly supported by a qualified contractor.

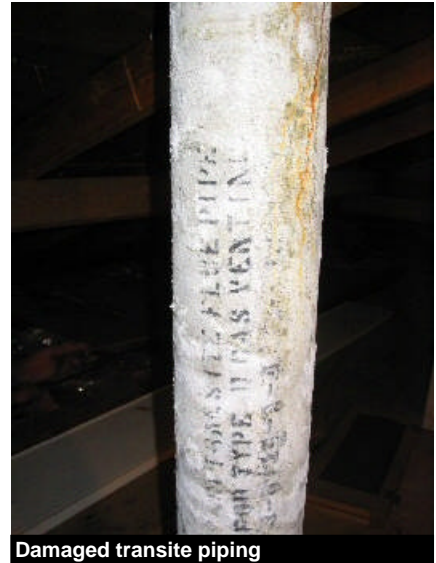
The apparent asbestos materials are damaged in several places. We recommend the apparent asbestos materials be examined and properly abated (sealed, painted, wrapped, or removed) as necessary by a qualified contractor.
