# Property Inspection Report

Prepared for  
Mr. and Mrs. Buyer

Inspection Address  
1234 Any Street  
Oakland, CA 94619

January 1, 2016

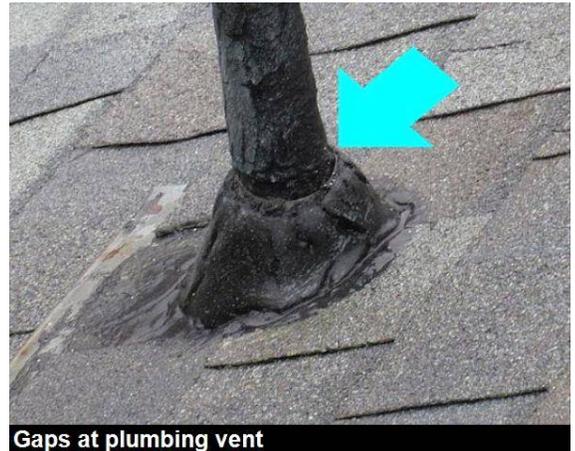
### PIPING PENETRATIONS

A piping penetration at the right front is not adequately sealed and we recommend the penetration flashing be sealed as needed by a qualified contractor.

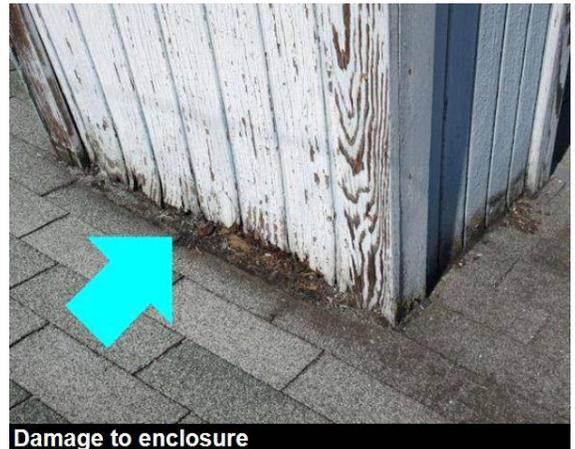
There is a wood-sided flue enclosure at the rear.

The enclosure siding is damaged and we recommend it be repaired or replaced as needed.

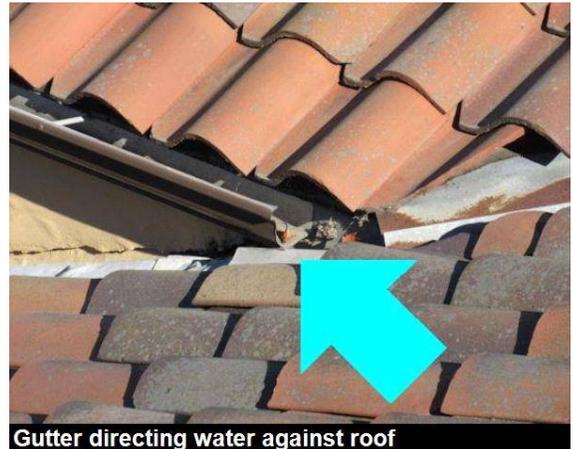
There are separations between the rain gutters and roof eaves. We recommend proper flashings are installed between the rain gutters and the roof edges as needed.

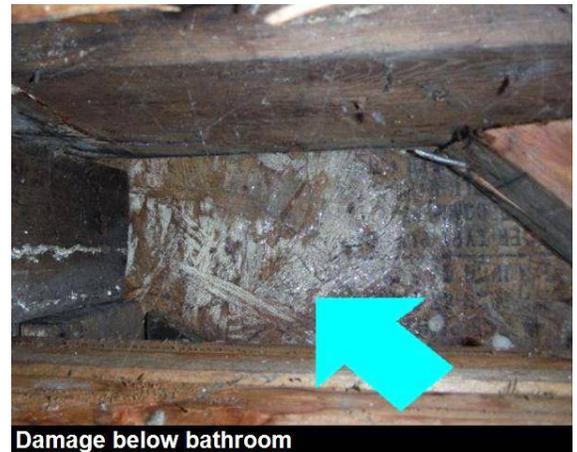
The subfloor area framing below the bathroom is damaged. We recommend the damaged wood be reviewed and replaced as needed by a qualified contractor.

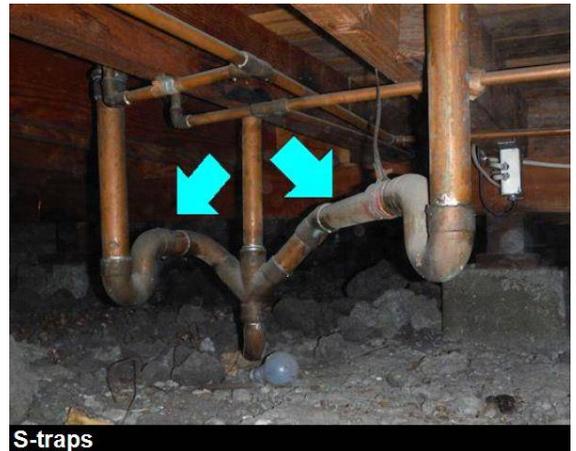
The hallway bathroom sub-floor area waste piping has S-traps, which are an improper configuration. We recommend this piping be properly installed by a qualified plumber.

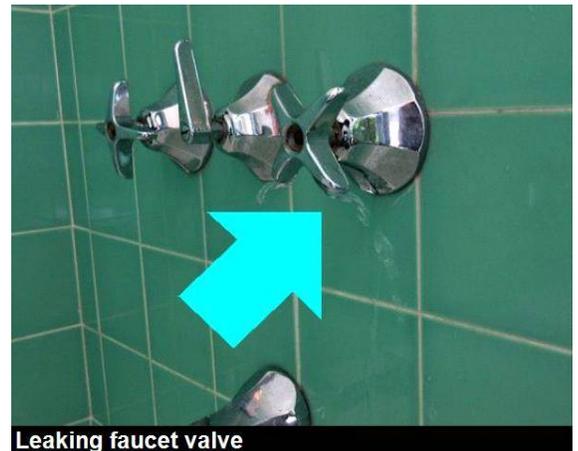
There is a gap at the bathtub fill spout. We recommend this joint be caulked to prevent water entry.

The tub hot water faucet leaks and we recommend it be repaired.
